24 July 1953

From: Commanding Officer, Naval Air Station, Pensacola, Florida  
To: Chief of Naval Air Basic Training

Subj: Engines and accessories recovered from RAQ-2 aircraft, BuNo 131663;  
disassembly and inspection of

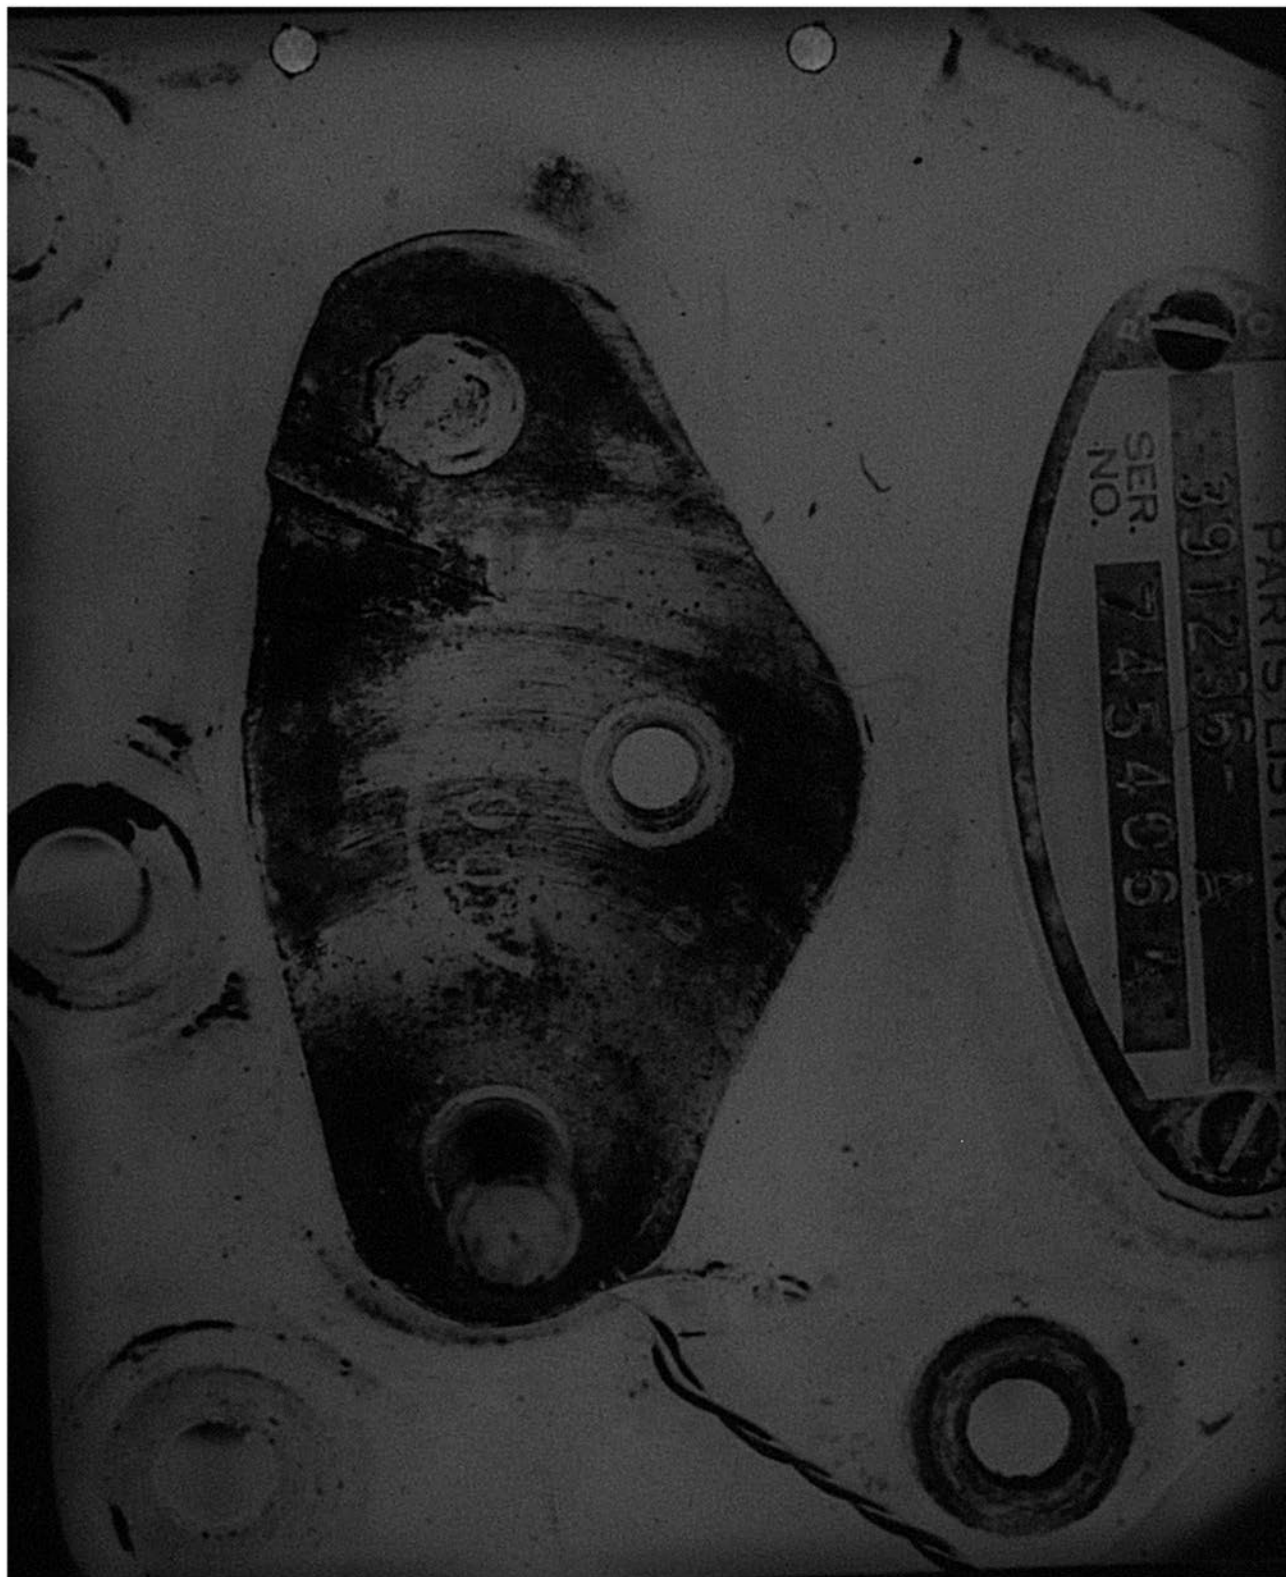
ENCLOSURE (5)

(d) All threads stripped from right hold down stud nut as shown in enclosure (5).

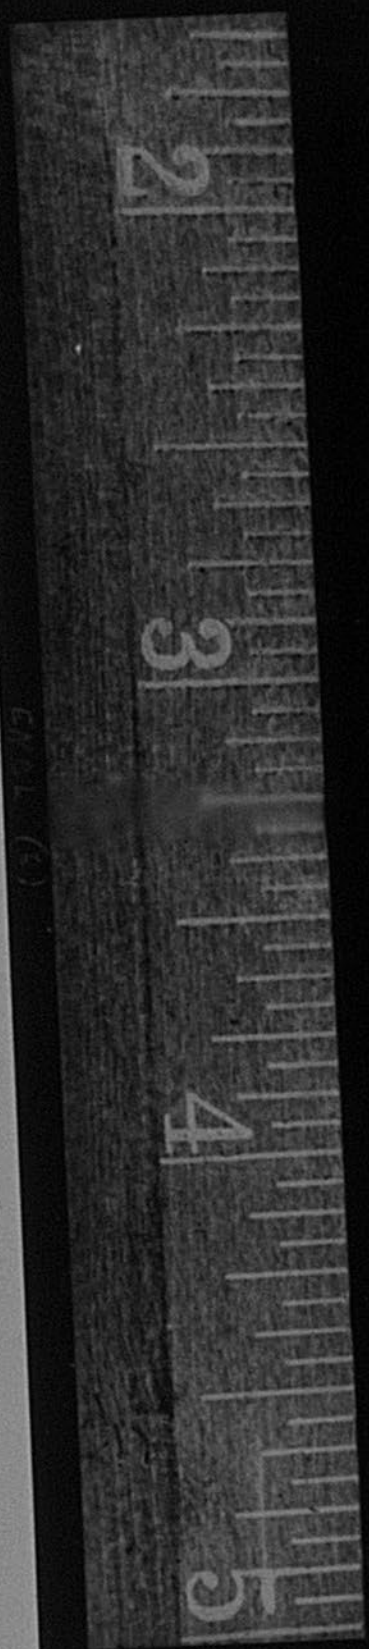
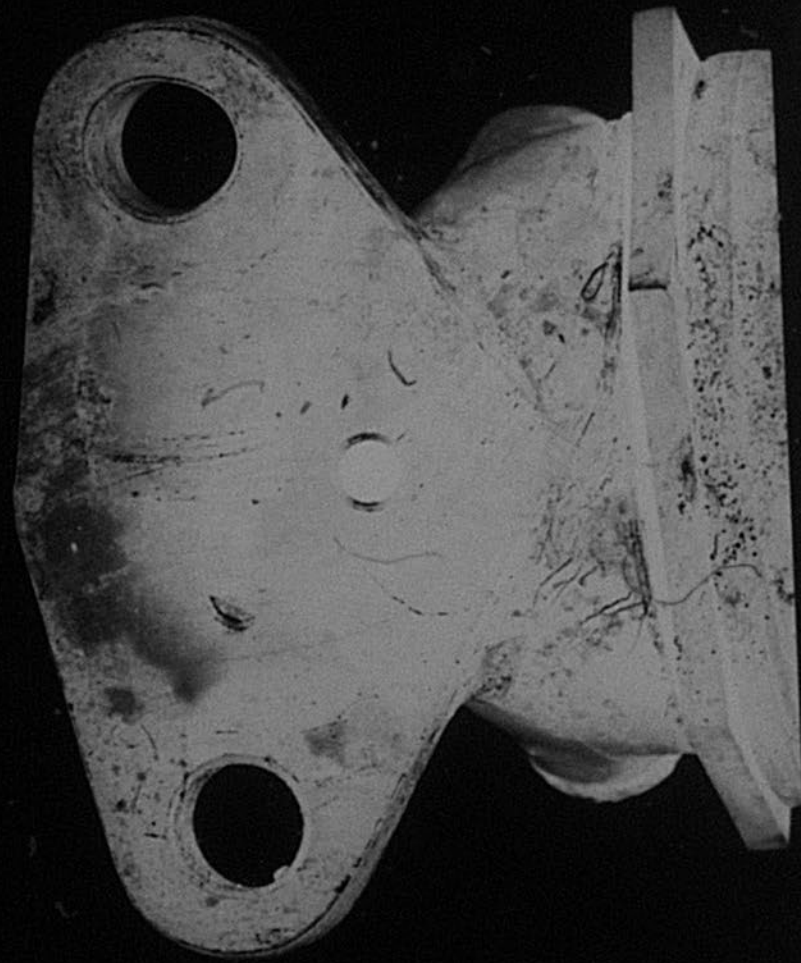
ENL (3)

(a) Primer burned, Bendix serial No. 24, as shown in enclosures (2) and (3).

(b) Left hold down stud sheared as shown in enclosures (2), (3) and (4).

(c) Right hold down stud bent as shown in enclosures (3) and (4).
